**Study Area Location Map**  
*Lower Passaic River Restoration Project*

*Lower Passaic River Restoration Project*

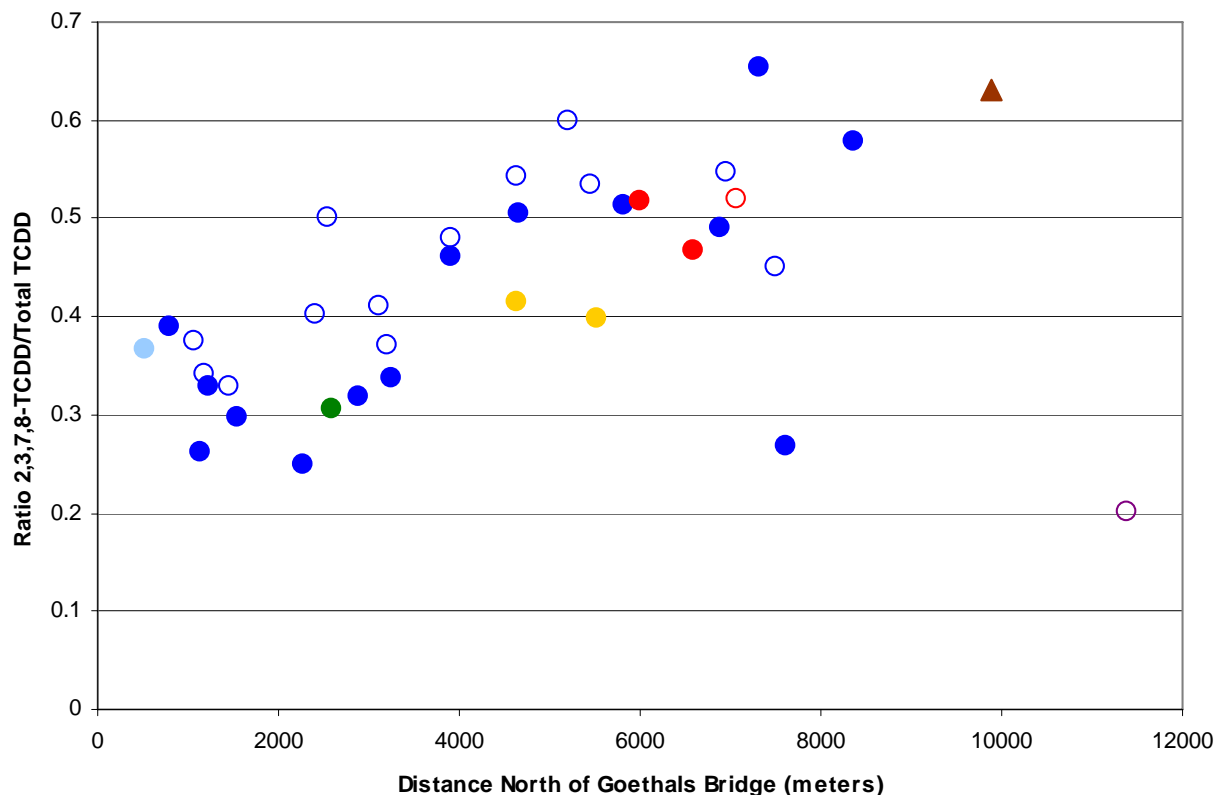
Figure 2-12

1. 2,3,7,8-TCDD and Total TCDD surface concentrations represent the top 6 inches of the core.
2. When duplicate 2,3,7,8-TCDD or Total TCDD values are provided by the laboratory, the average ratio is plotted.
3. No nondetected 2,3,7,8-TCDD or Total TCDD values were reported for the surface sediment.
4. Concentration ratios are plotted only for depositional environments, indicated by Beryllium-7 detections more than 0.5 pCi/g in the top inch of the core.
5. Data Source: Malcolm Pirnie, Inc. High Resolution Sediment Core in the Lower Passaic River (RM1.4). USEPA 2005-2006 Sampling Program.
6. Data Source: Newark Bay Phase 2 Remedial Investigation Work Plan (October 2006). Samples collected in October to December 2005.

Ratio of 2,3,7,8-TCDD/Total TCDD in Newark Bay  
Surface Sediments  
*Lower Passaic River Restoration Project*

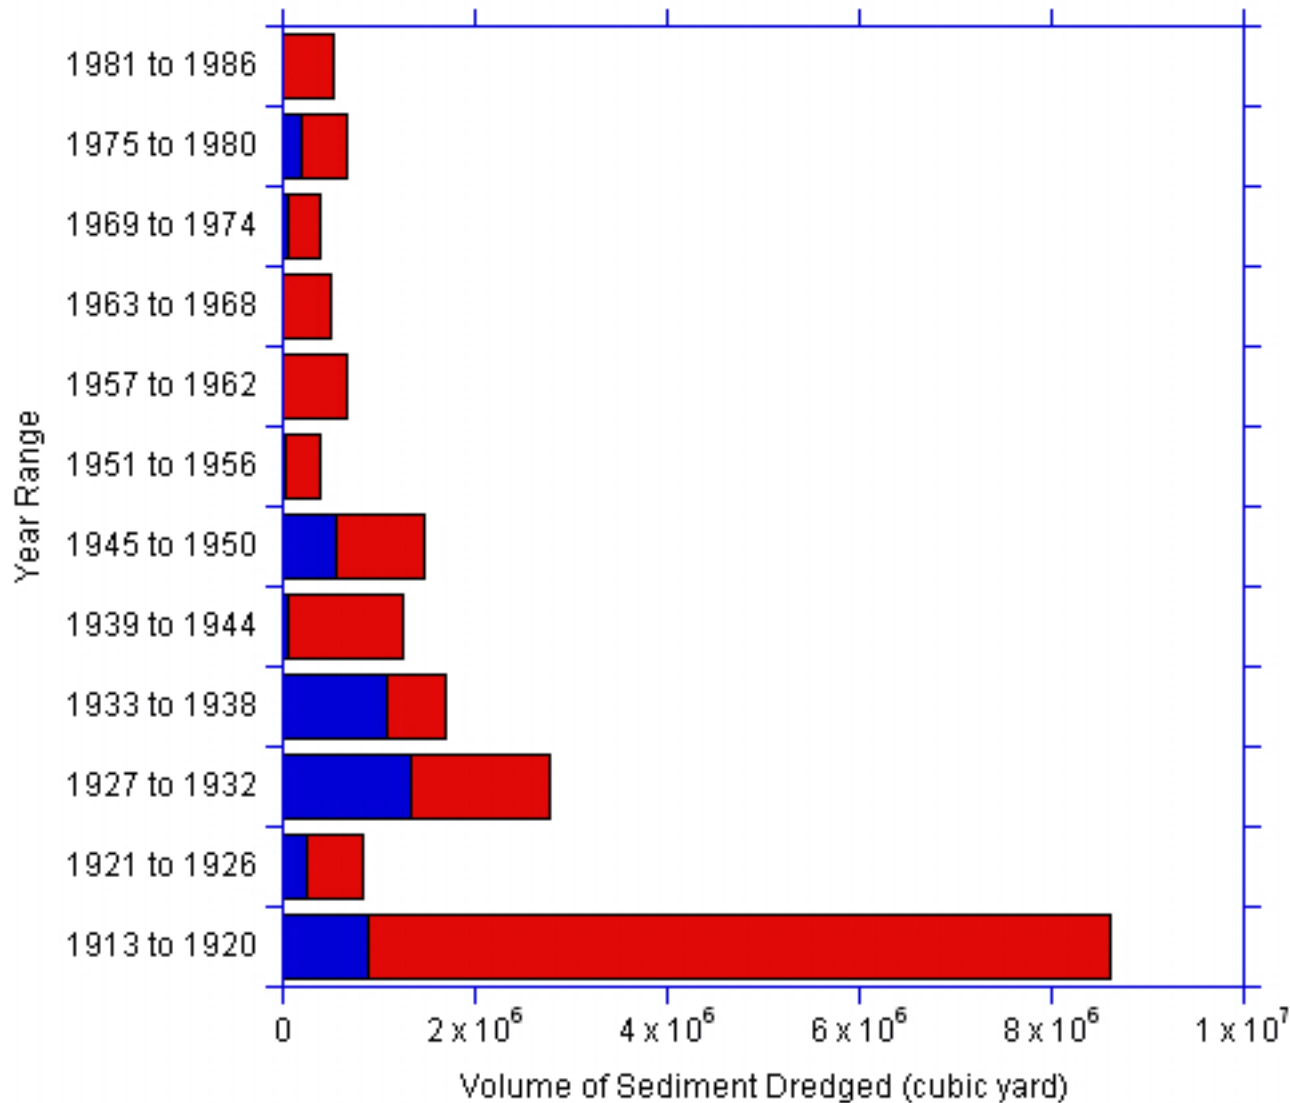
Figure 2-13

Data Sources: USACE, 1880, USACE, 1884, USACE, 1900, USACE, 1907, USACE, 1913, USACE, 1915, USACE, 1916, and USACE, 1917 as cited in Iannuzzi, *et al.*, 2002 (refer to Section 10 "References" for complete citation).

The History of Dredging in the Lower Passaic River

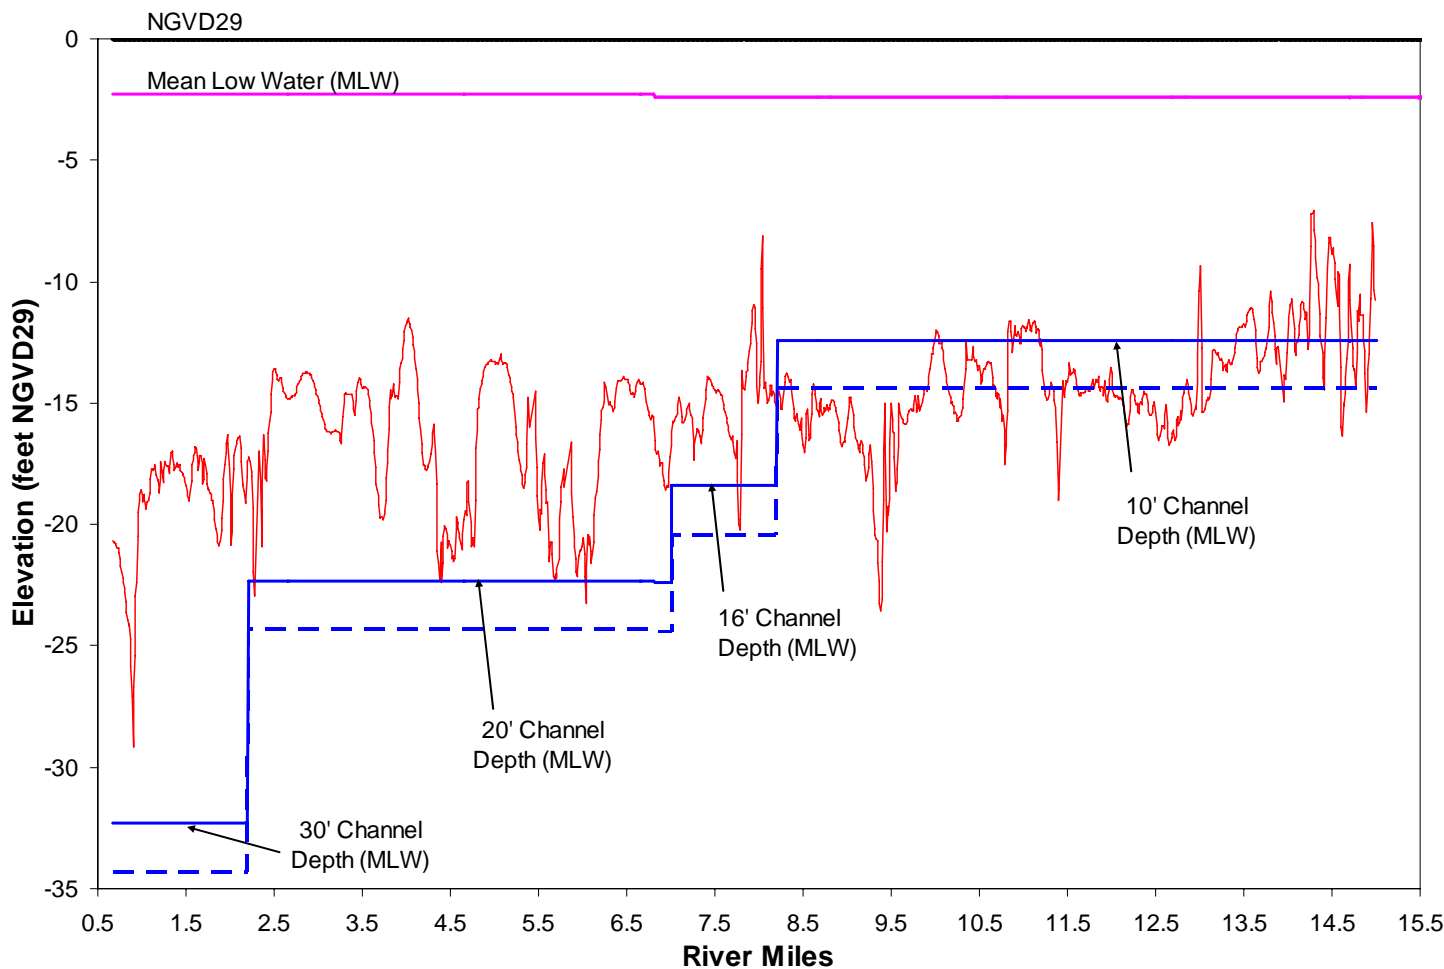
Figure 2-14

Channel depths were dredged relative to mean low water (MLW). The difference between NGVD29 and MLW is approximately 2.3 feet.

Solid blue line represents federally mandated channel depth.

Dashed blue line represents the channel depth +2 feet which would have been the dredged depth in order to maintain the federally specified channel depth.

Elevation data estimated from 2004 bathymetric data surveyed by Rogers Survey, Inc. for USACE.

## River Bottom Elevation and Authorized Channel Depths

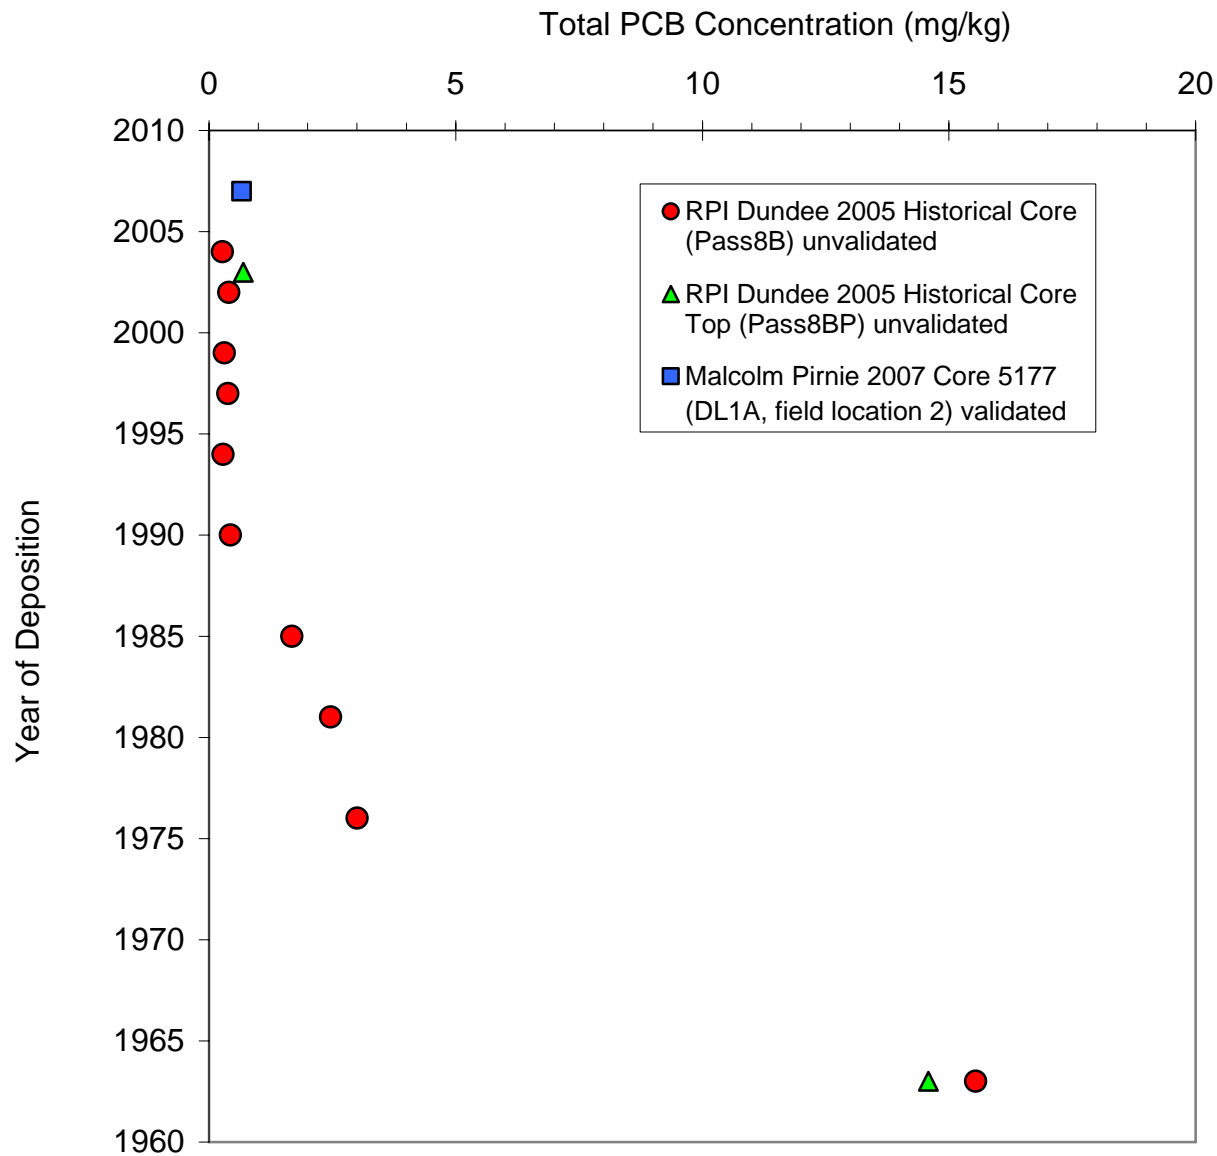
Figure 5-1

### Total PCB Downcore Profile

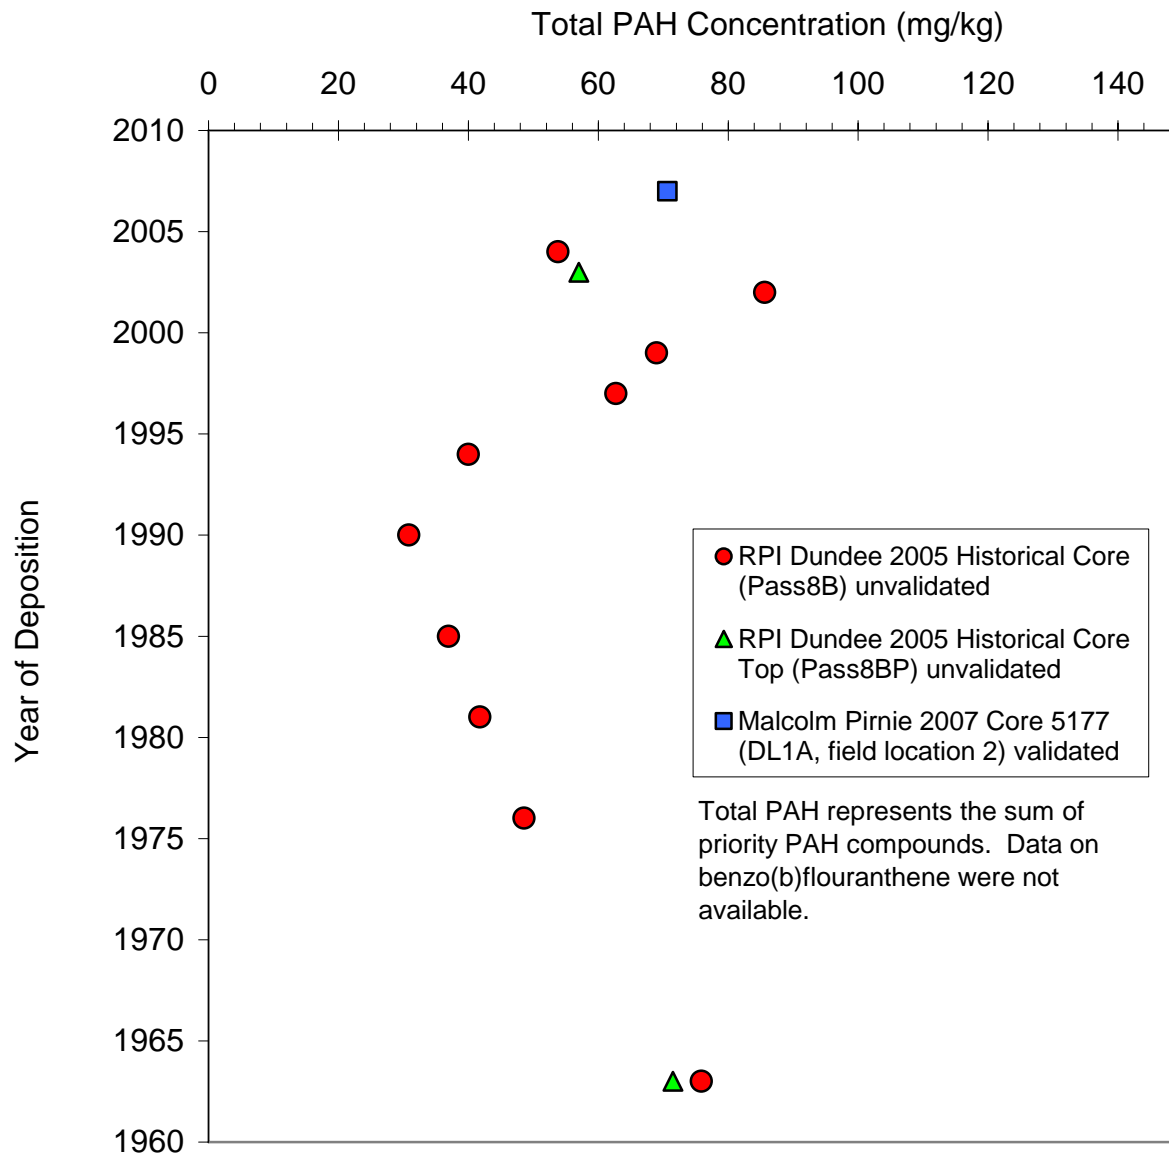
Figure 5-2

### Total PAH Downcore Profile

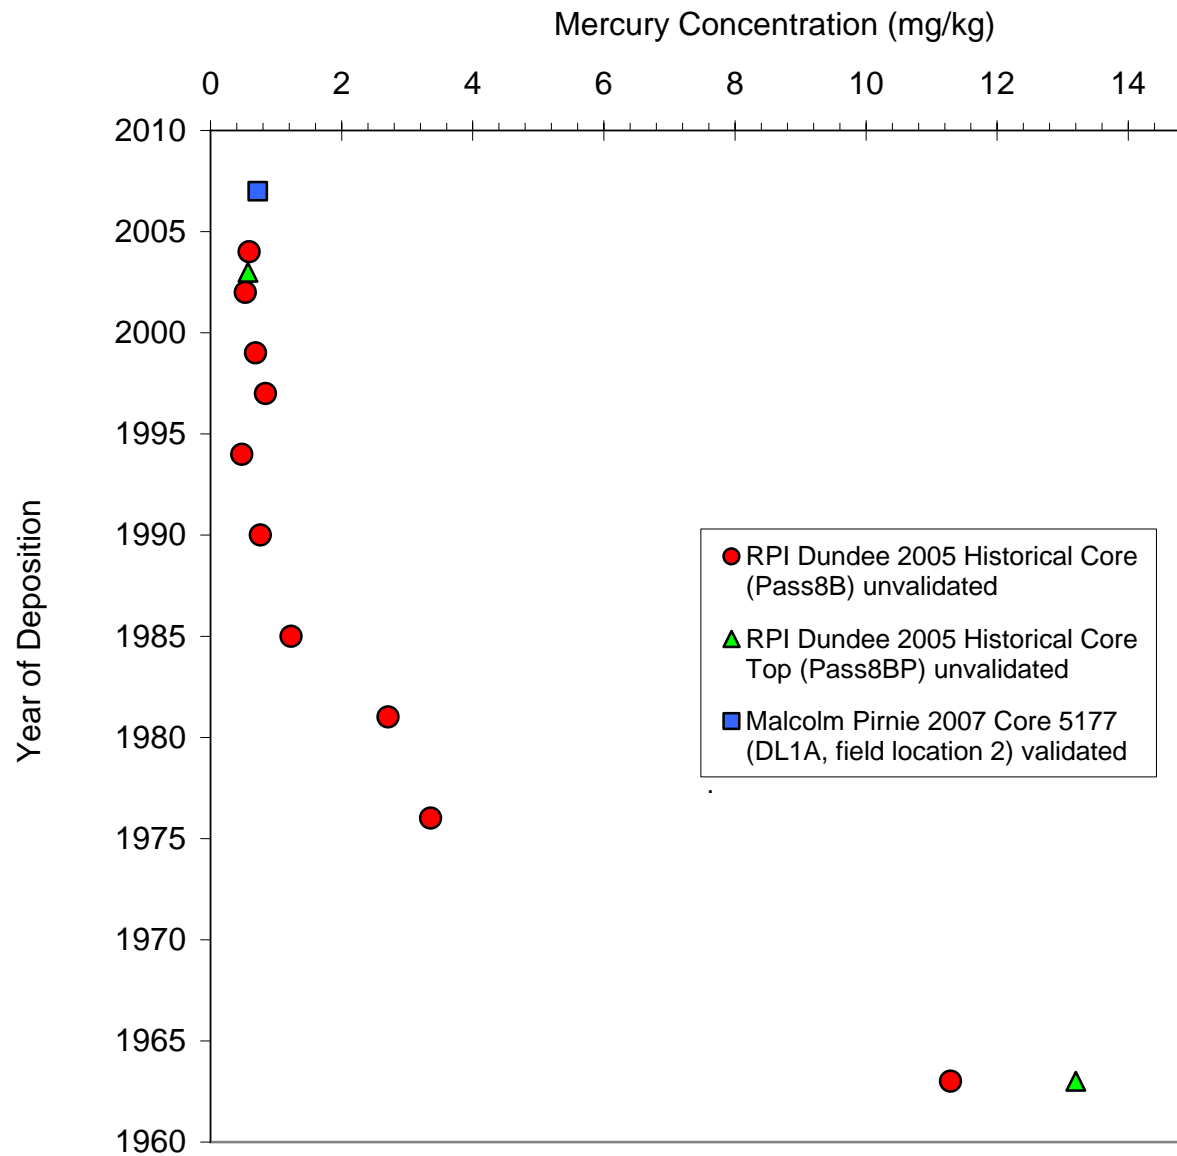
Figure 5-4

# Mercury Downcore Profile

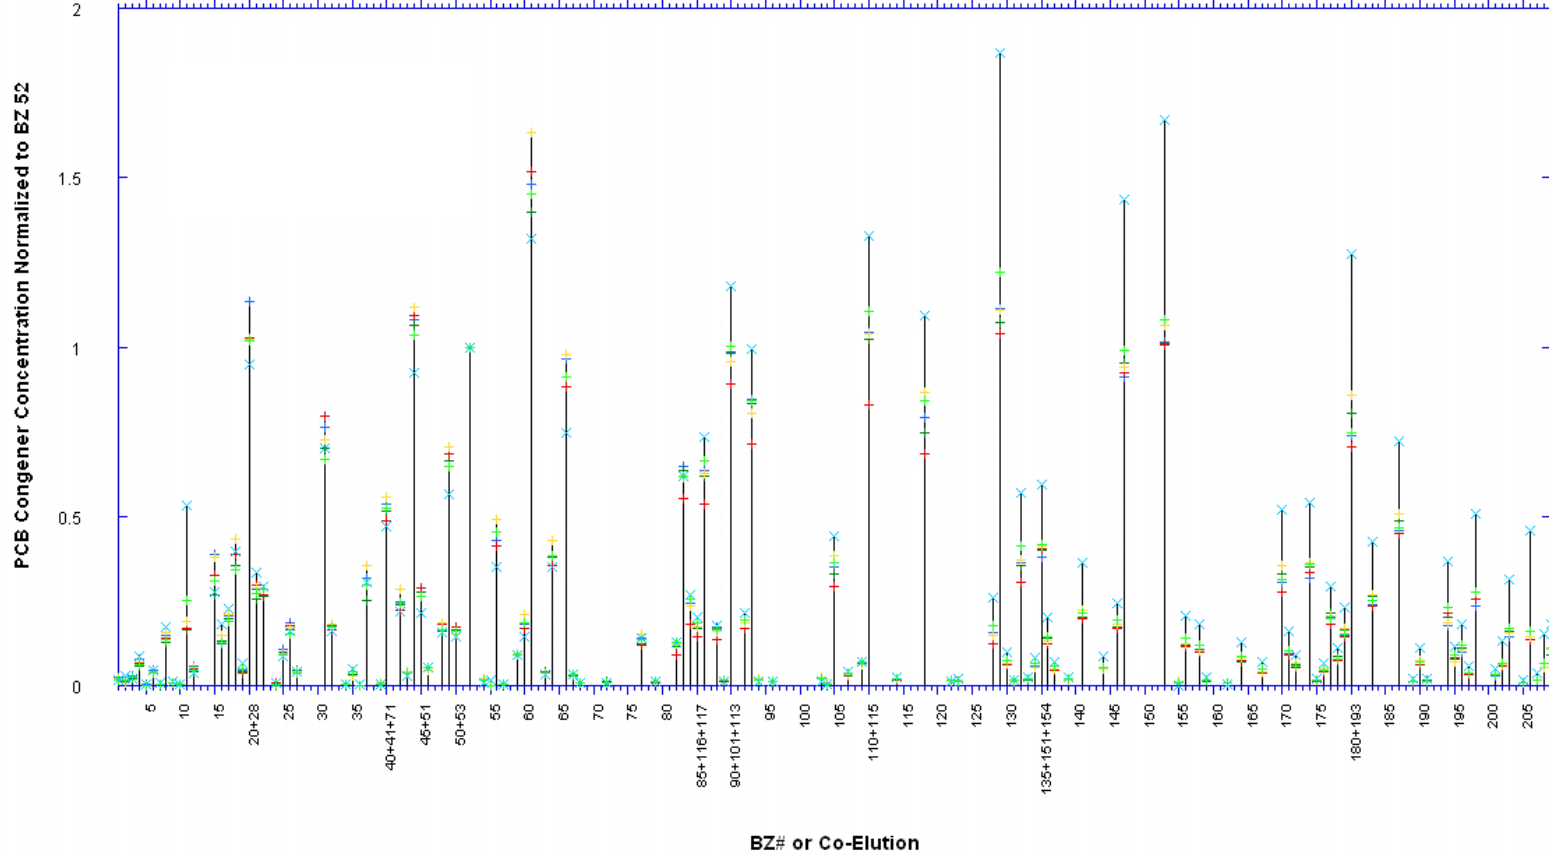
Figure 5-5

Normalized PCB Congener ratios <0.01 are not plotted.

Normalized PCB Congener Pattern for Dundee Dam and Lower Passaic River

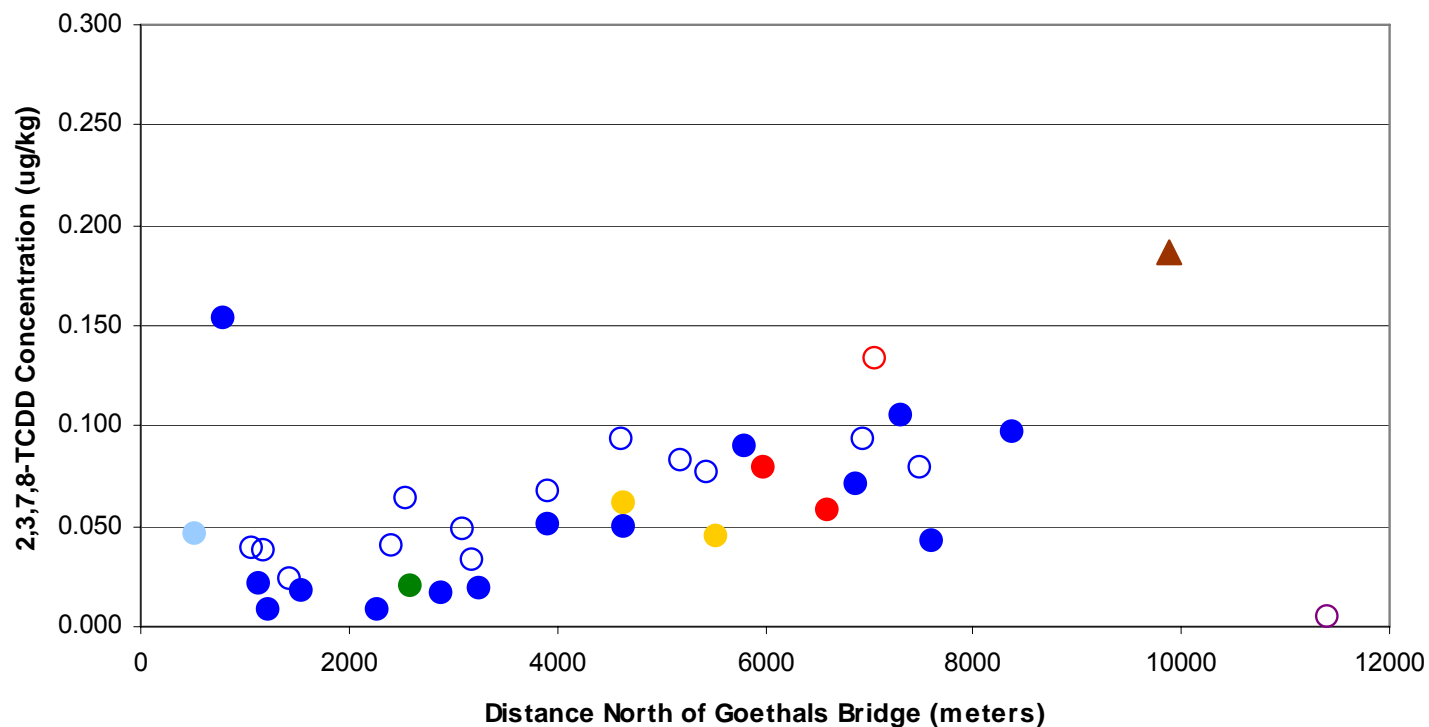
Figure 6-2a

1. 2,3,7,8-TCDD surface concentrations represent the top 6 inches of the core.
2. When duplicate 2,3,7,8-TCDD values are provided by the laboratory, the average concentration is plotted.
3. No nondetected 2,3,7,8-TCDD values were reported for the surface sediment.
4. 2,3,7,8-TCDD concentrations are plotted only for depositional environments, indicated by Beryllium-7 detections more than 0.5 pCi/g in the top inch of the core.
5. Data Source: Malcolm Pirnie, Inc. High Resolution Sediment Core in the Lower Passaic River (RM 1.4). USEPA 2005 Sampling Program.
6. Data Source: Newark Bay Phase 2 RIWP (October 2006). Samples collected in October to December 2005.

## 2,3,7,8-TCDD Surface Sediment Concentrations in Newark Bay Complex

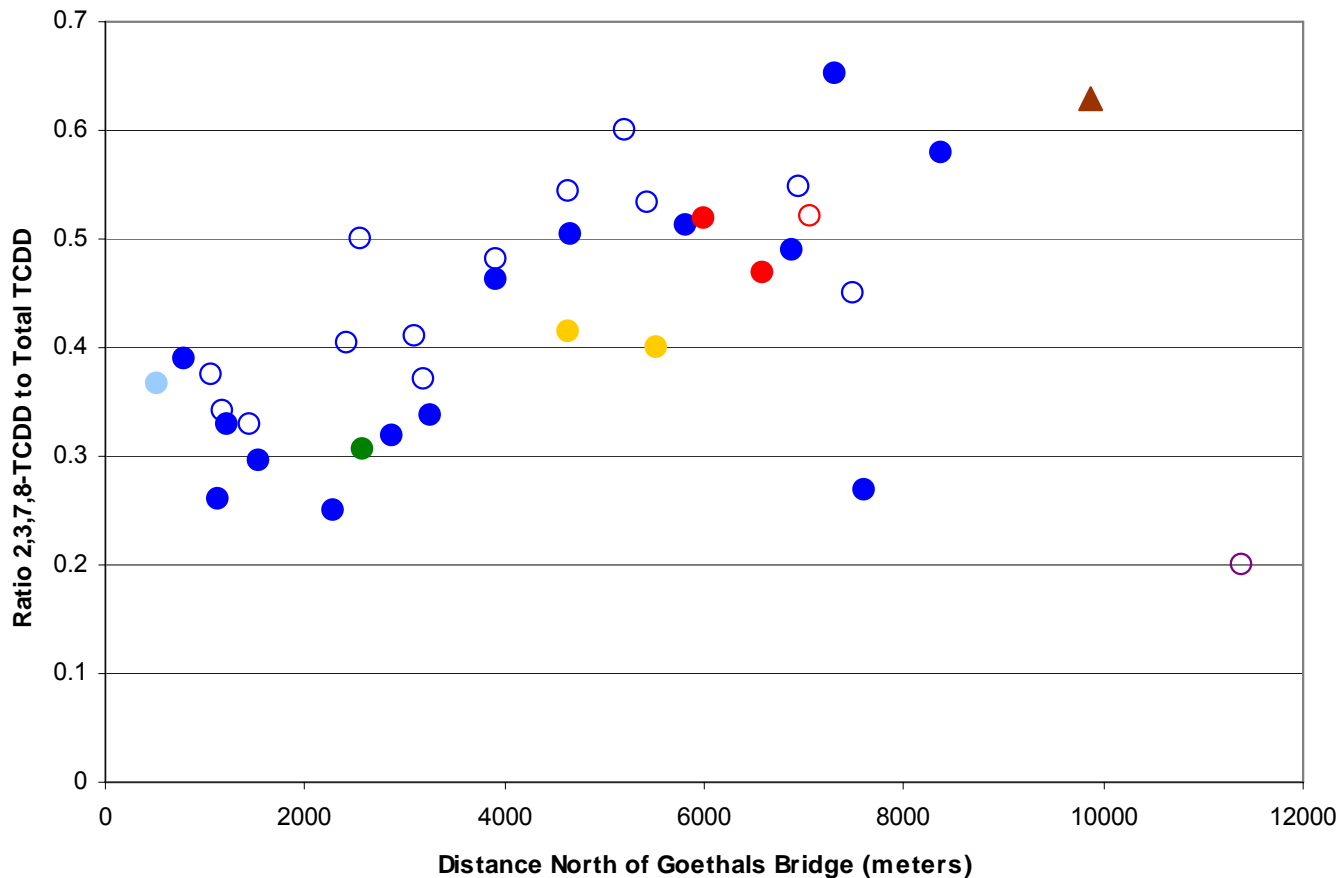
Figure 6-2b

1. 2,3,7,8-TCDD and Total TCDD surface concentrations represent the top 6 inches of the core.
2. When duplicate 2,3,7,8-TCDD or Total TCDD values are provided by the laboratory, the average ratio is plotted.
3. No nondetected 2,3,7,8-TCDD or Total TCDD values were reported for the surface sediment.
4. Concentration ratios are plotted only for depositional environments, indicated by Beryllium-7 detections more than 0.5 pCi/g in the top inch of the core.
5. Data Source: Malcolm Pirnie, Inc. High Resolution Sediment Core in the Lower Passaic River (RM 1.4). USEPA 2005 Sampling Program.
6. Data Source: Newark Bay Phase 2 RIWP (October 2006). Samples collected in October to December 2005.

Ratio of 2,3,7,8-TCDD to Total TCDD Surface Sediments Concentrations in Newark Bay Complex

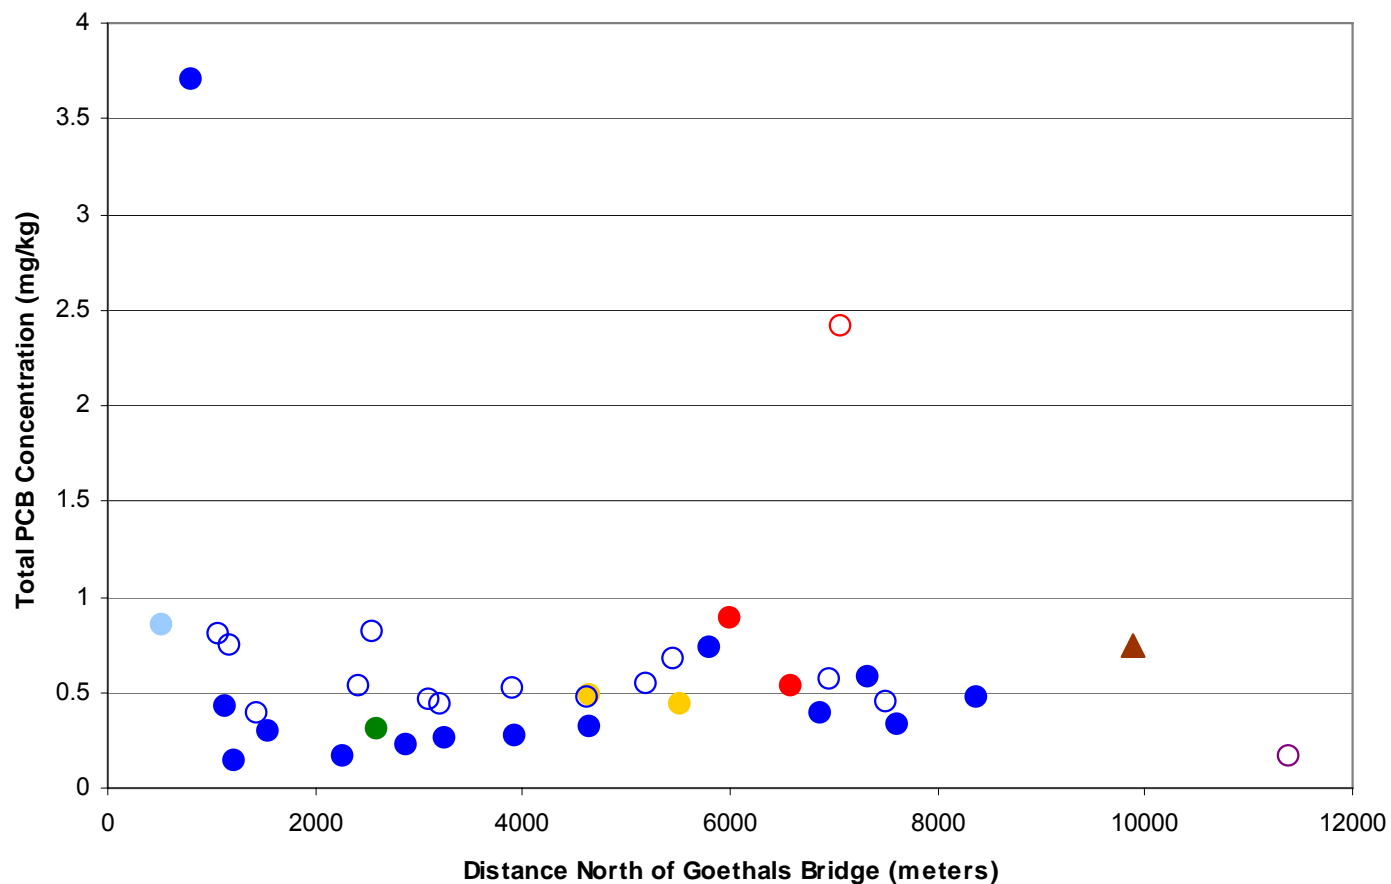
Figure 6-2c

1. Total PCB surface concentrations represent the top 6 inches of the core.
2. Total PCB represents the sum of 209 congeners with nondetected values incorporated into the sum as zero.
3. When duplicate PCB congener values are provided by the laboratory, the average concentration is used in the summation.
4. Total PCB concentrations are plotted only for depositional environments, indicated by Beryllium-7 detections more than 0.5 pCi/g in the top inch of the core.
5. Data Source: Malcolm Pirnie, Inc. High Resolution Sediment Core in the Lower Passaic River (RM 1.4). USEPA 2005 Sampling Program.
6. Data Source: Newark Bay Phase 2 RIWP (October 2006). Samples collected in October to December 2005.

## Total PCB Surface Sediments Concentrations in Newark Bay Complex

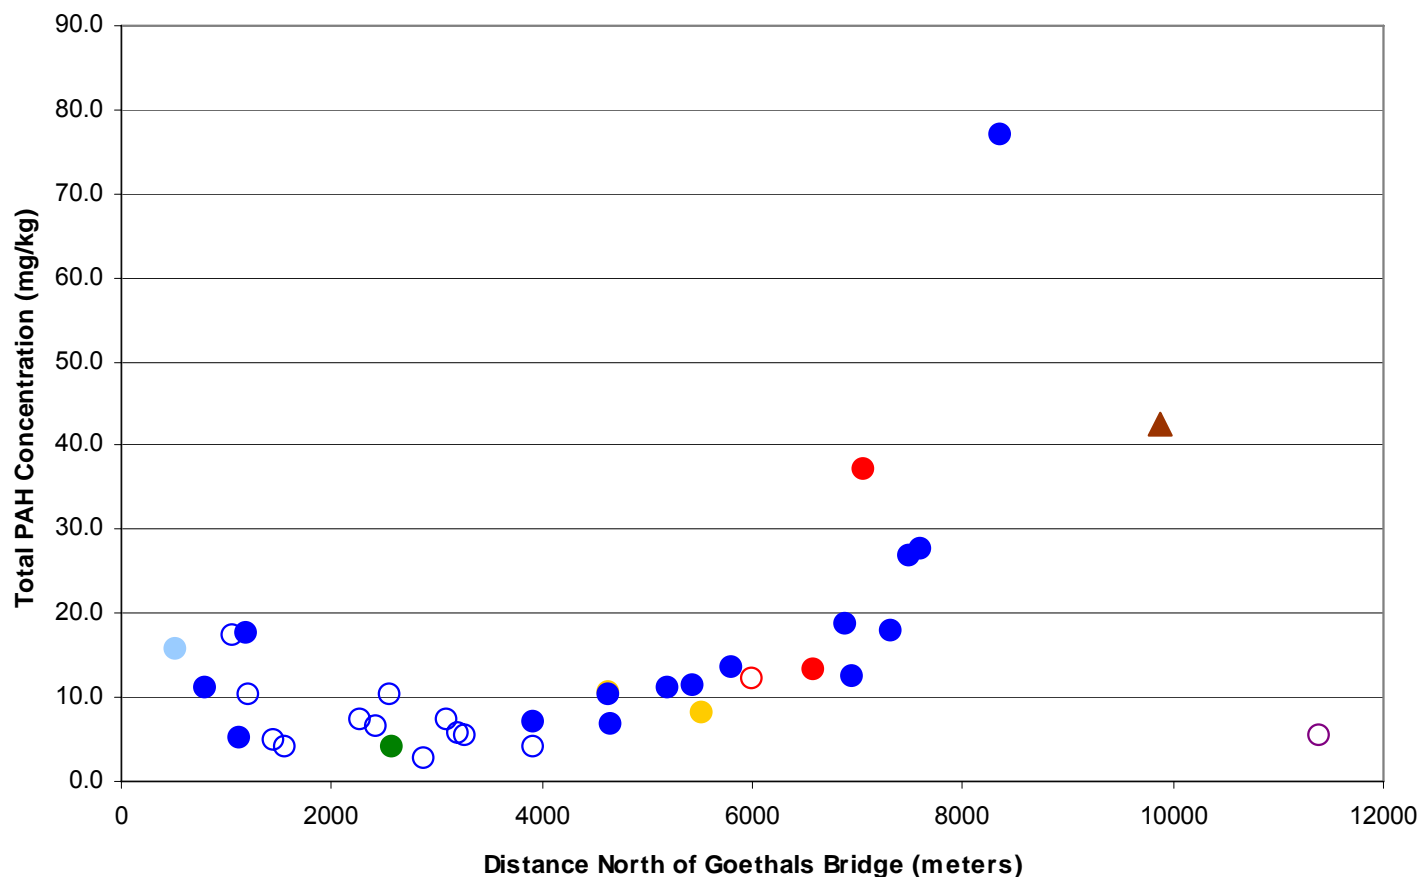
Figure 6-2d

1. Total PAH surface concentrations represent the top 6 inches of the core.
2. The Total PAH value is the sum of the 16 PAHs listed in the USEPA Priority List with nondetected values incorporated into the sum as zero.
3. When duplicate PAH values are provided by the laboratory, the average concentration is used in the summation.
4. Total PAH concentrations are plotted only for depositional environments, indicated by Beryllium-7 detections more than 0.5 pCi/g in the top inch of the core.
5. Data Source: Malcolm Pirnie, Inc. High Resolution Sediment Core in the Lower Passaic River (RM 1.4). USEPA 2005 Sampling Program.
6. Data Source: Newark Bay Phase 2 RIWP (October 2006). Samples collected in October to December 2005.

## Total PAH Surface Sediments Concentrations in Newark Bay Complex

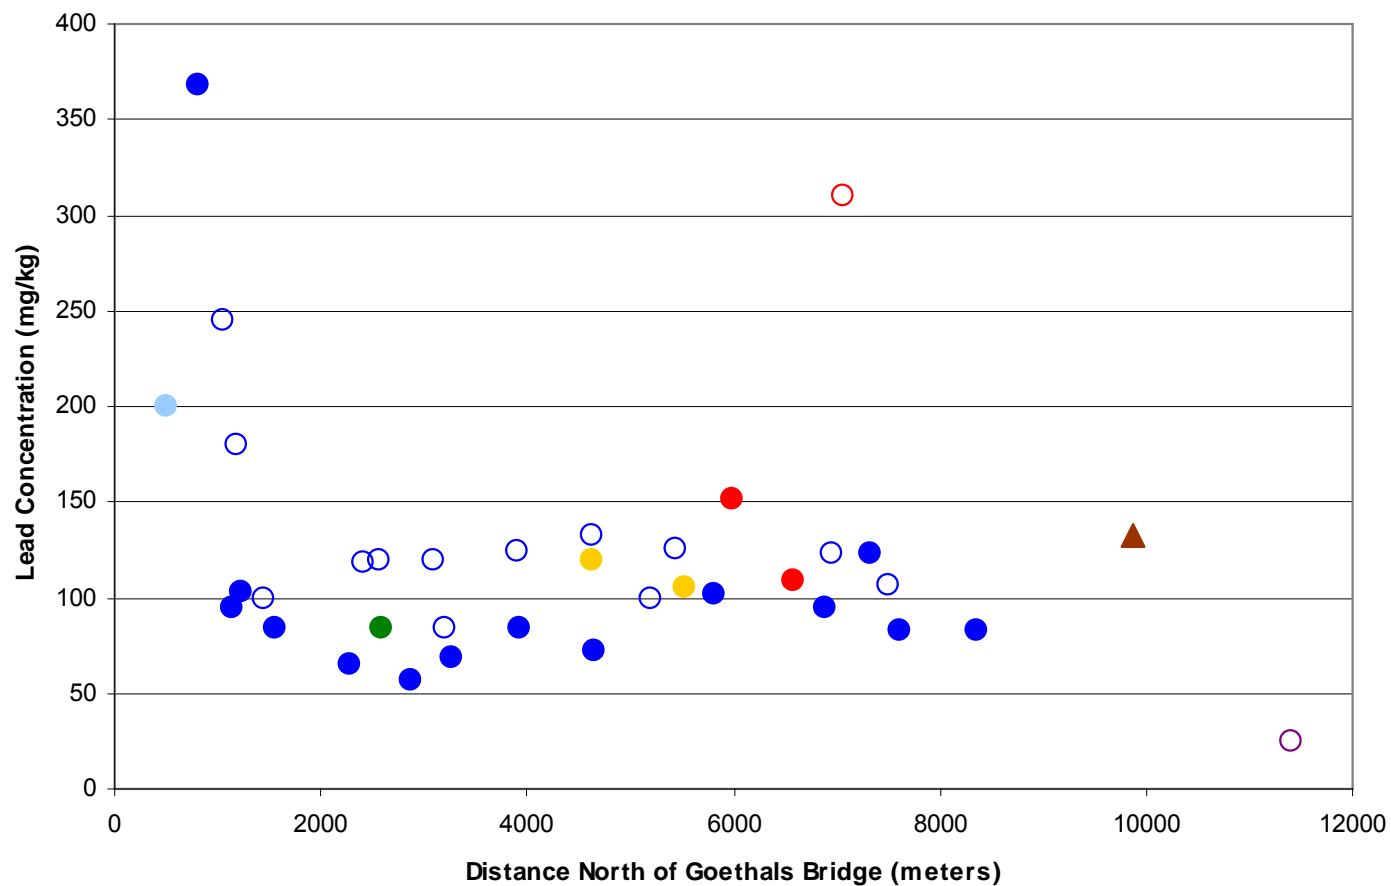
Figure 6-2e

1. Lead surface concentrations represent the top 6 inches of the core.
2. When duplicate lead values are provided by the laboratory, the average lead concentration is plotted.
3. No nondetected lead values were reported for the surface sediment.
4. Lead concentrations are plotted only for depositional environments, indicated by Beryllium-7 detections more than 0.5 pCi/g in the top inch of the core.
5. Data Source: Malcolm Pirnie, Inc. High Resolution Sediment Core in the Lower Passaic River (RM 1.4). USEPA 2005 Sampling Program.
6. Data Source: Newark Bay Phase 2 RIWP (October 2006). Samples collected in October to December 2005.

## Lead Surface Sediment Concentrations in Newark Bay Complex

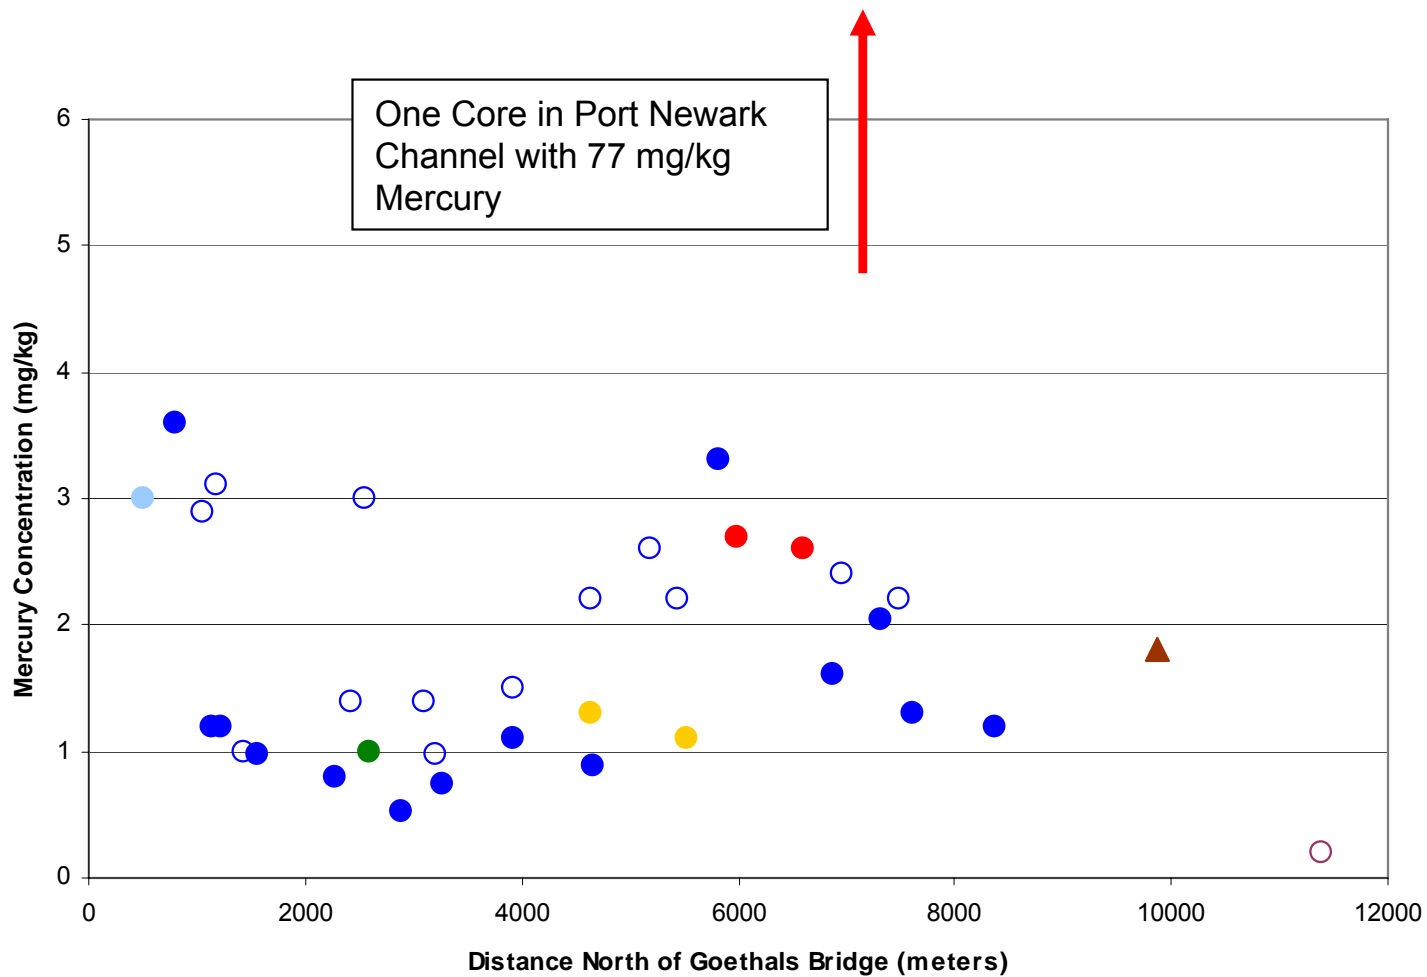
Figure 6-2f

1. Mercury surface concentrations represent the top 6 inches of the core.
2. When duplicate mercury values are provided by the laboratory, the average mercury concentration is plotted.
3. No nondetected mercury values were reported for the surface sediment.
4. Mercury concentrations are plotted only for depositional environments, indicated by Beryllium-7 detections more than 0.5 pCi/g in the top inch of the core.
5. Data Source: Malcolm Pirnie, Inc. High Resolution Sediment Core in the Lower Passaic River (RM 1.4). USEPA 2005 Sampling Program.
6. Data Source: Newark Bay Phase 2 RIWP (October 2006). Samples collected in October to December 2005.

## Mercury Surface Sediment Concentrations in Newark Bay Complex

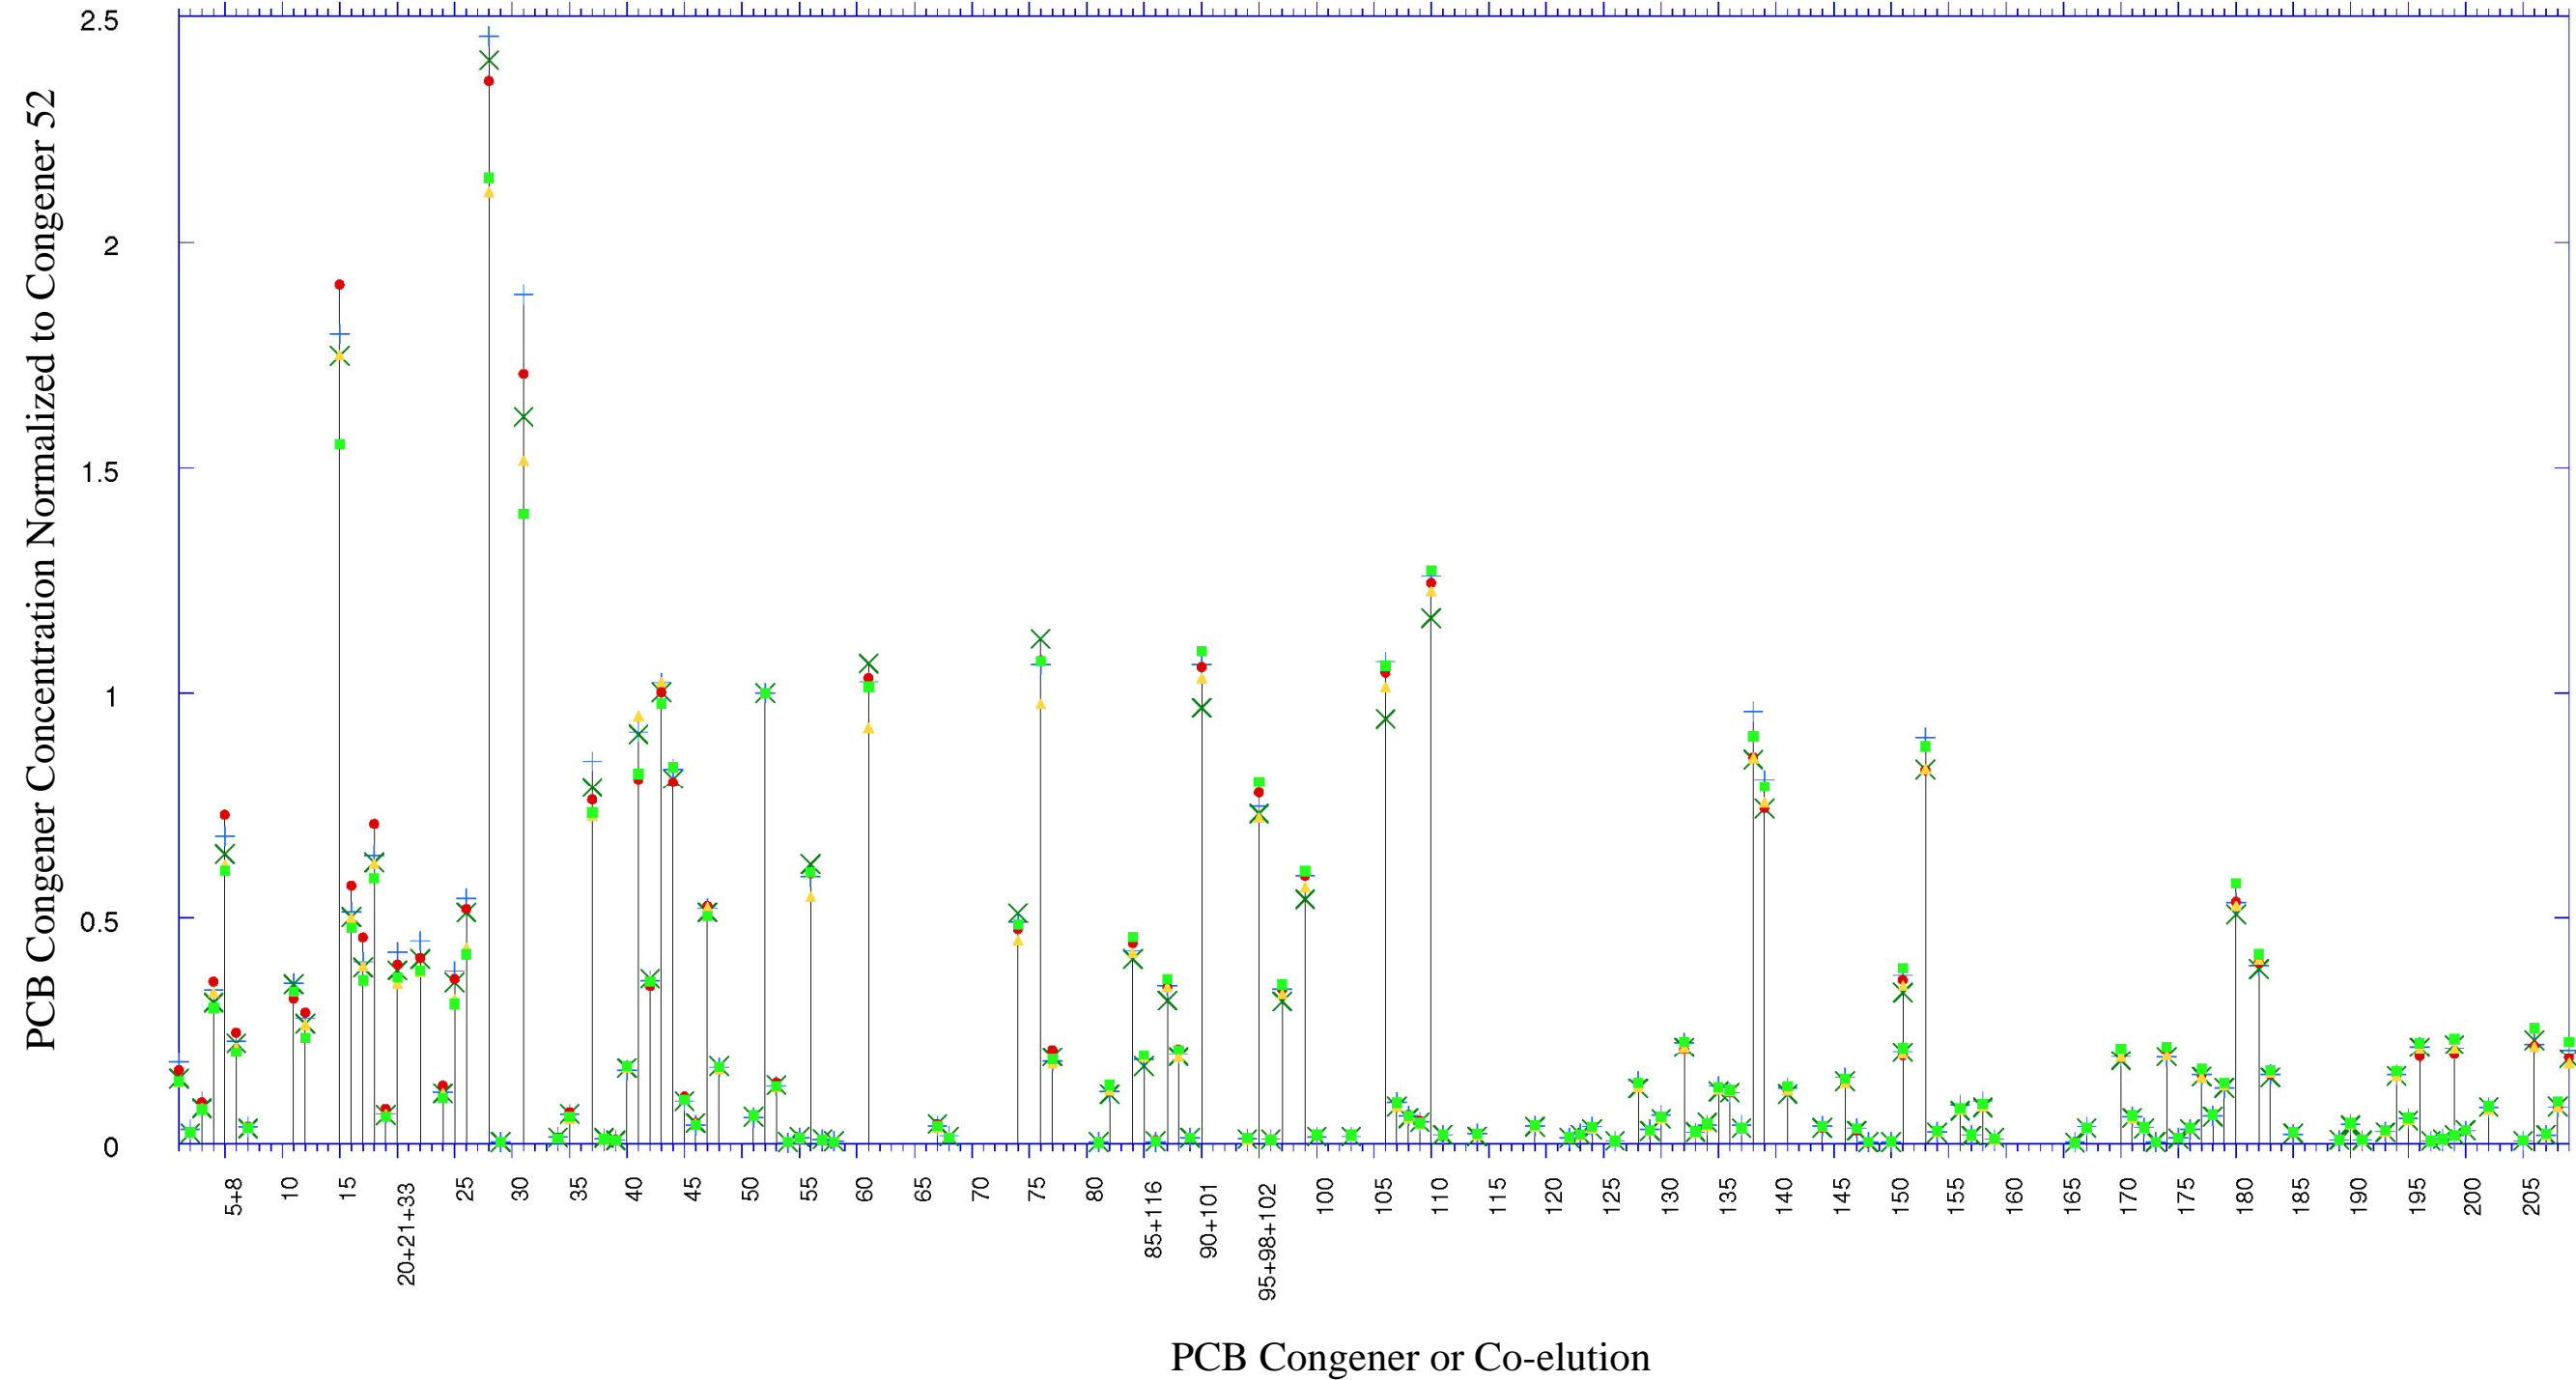
Figure 6-6

PCB Congener Concentration Normalized to Congener 52 Pattern for Southern Locations in Newark Bay

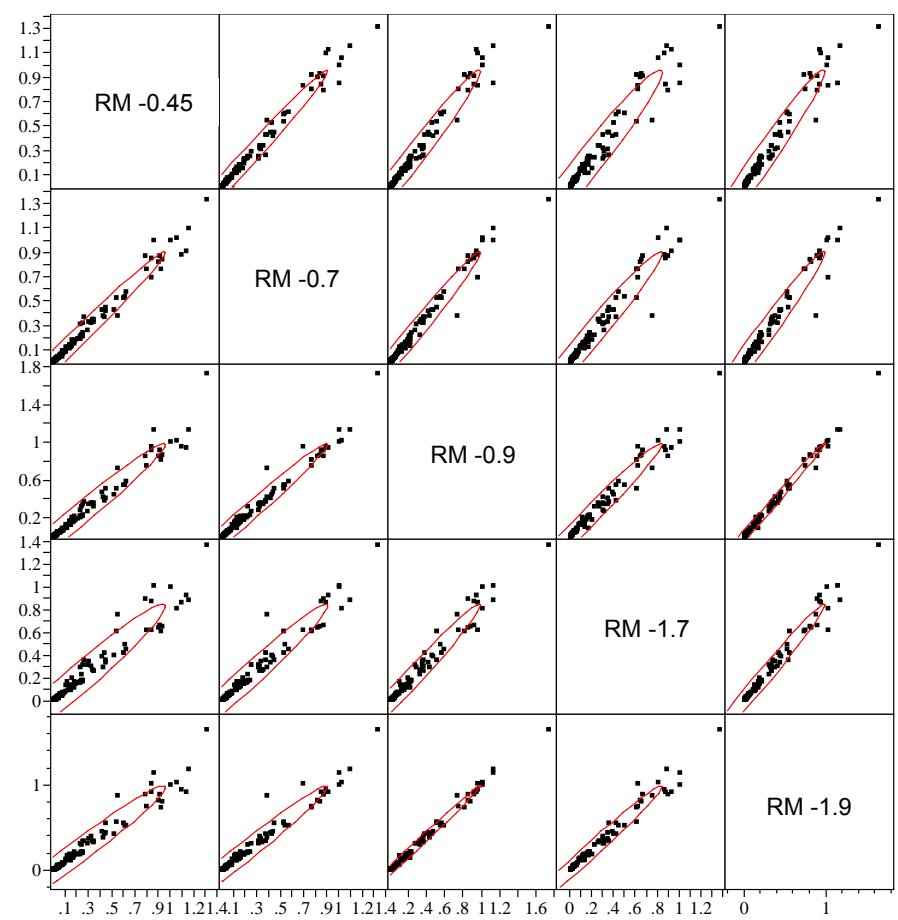
Figure 6-7

In this presentation, river miles for the Newark Bay sampling locations are assigned with respect to the distance from the mouth of the Lower Passaic River (RM0.0) and following the federal navigation channel.

Correlation Among Sampling Locations of PCB Congeners Concentration Normalized to Congener 52 in Northern Newark Bay Samples
